P.I.N. X051.59  
BRIDGE DECK EVALUATION REPORT

<u>Description:</u>	Grand Central Parkway over Winchester Blvd and Cross Island Parkway and Ramp "H" over Cross Island Parkway
<u>BIN:</u>	1065149 and 106514A
<u>GCP Reference Marker:</u>	1120 to 1124
<u>County:</u>	Queens
<u>City of:</u>	New York
<u>Region:</u>	11
<u>Feature Carried:</u>	Grand Central Parkway and GCP Ramp "H"
<u>Feature Crossed:</u>	Cross Island Parkway Winchester Blvd

# IN-DEPTH INSPECTION REPORT

**B.I.N. 1-06514-9 & 1-06514-A**

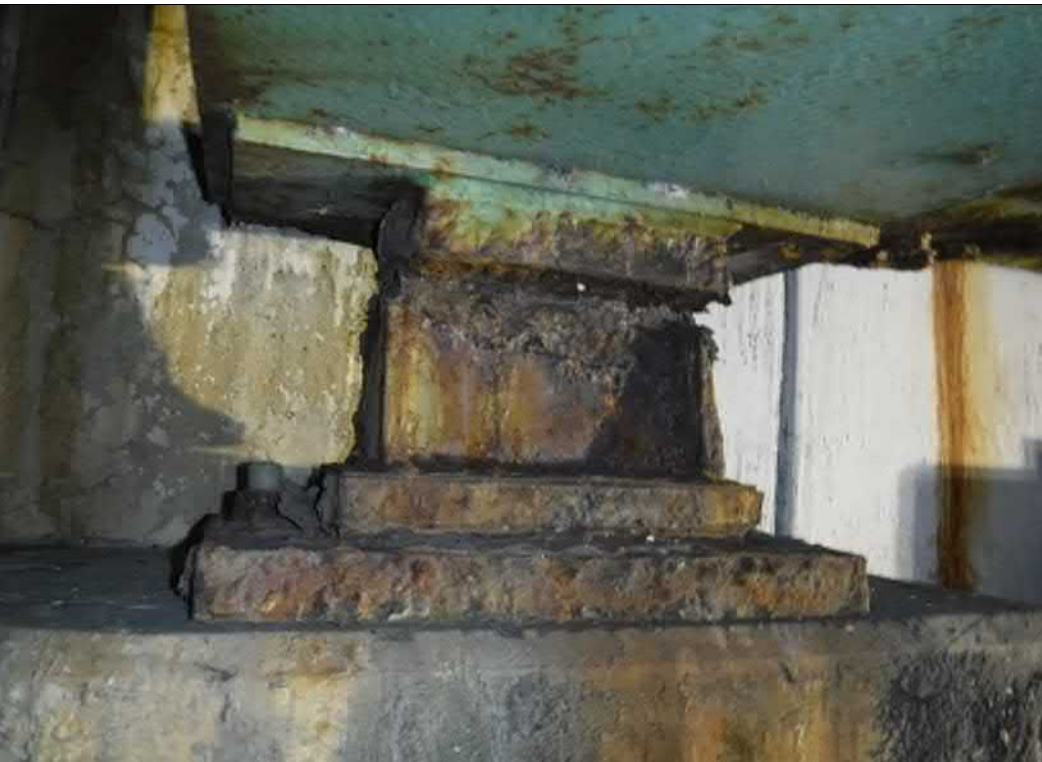
<b>PHOTO: 3</b>	<b>LOCATION:</b> <u>Pier 9 Span 10 side Bearing under girder G2</u> <b>DESCRIPTION:</b> <u>Bearing exhibits pack rust under rocker, bearing</u> <u>Over-expanded, Looking North</u>

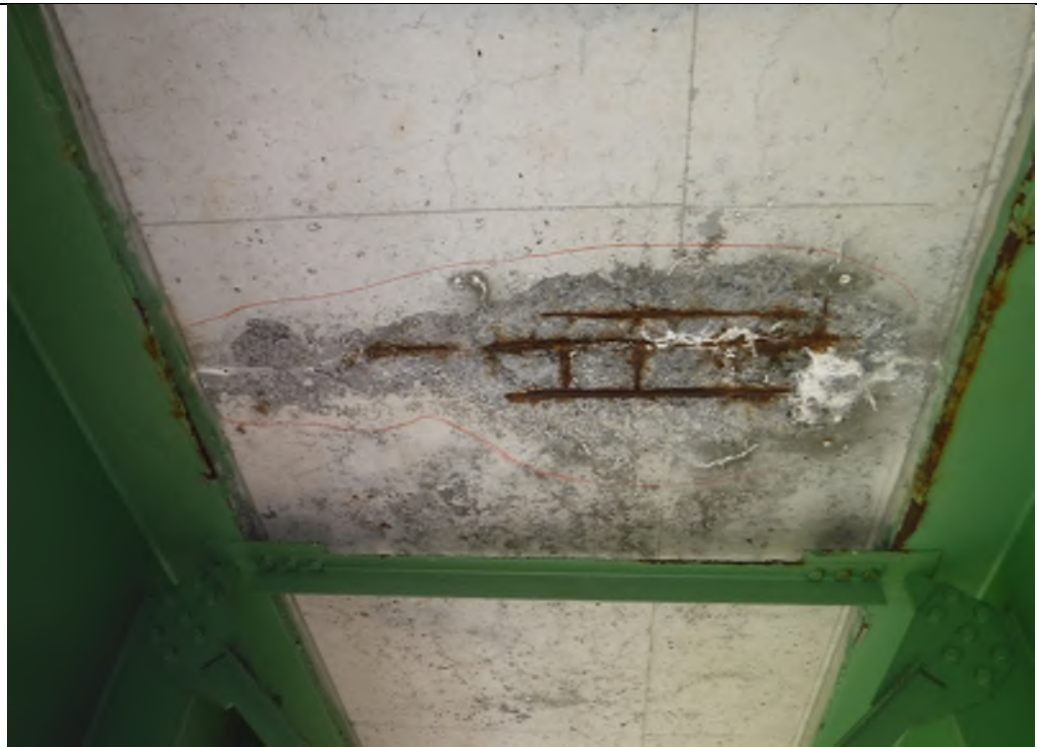
<b>PHOTO: 15</b>	<b>LOCATION:</b> <u>Span 4 Bay 12 between diaphragms D3-D4</u> <b>DESCRIPTION:</b> <u>Underside of deck exhibits a 5 SF spall with exposed rebar</u> <u>Looking East</u>

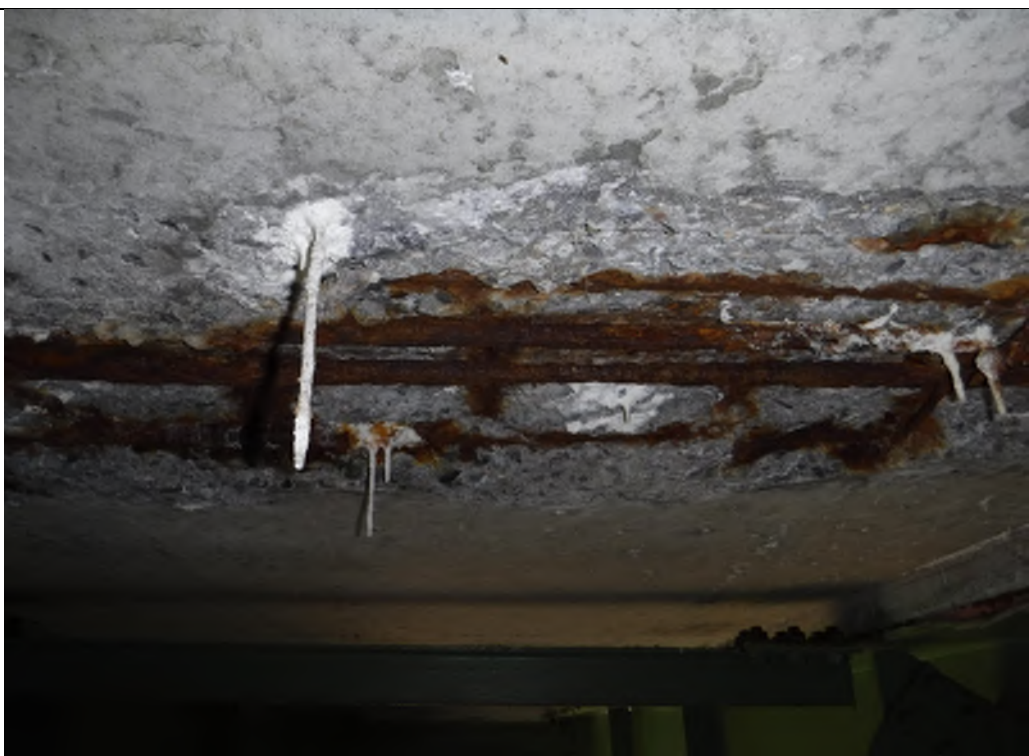
<b>PHOTO: 21</b>	<b>LOCATION:</b> <u>Span 9 Bay 17 near diaphragm D1</u> <b>DESCRIPTION:</b> <u>Underside of deck exhibits a 12 SF spall with exposed rebar</u> <u>Looking East</u>

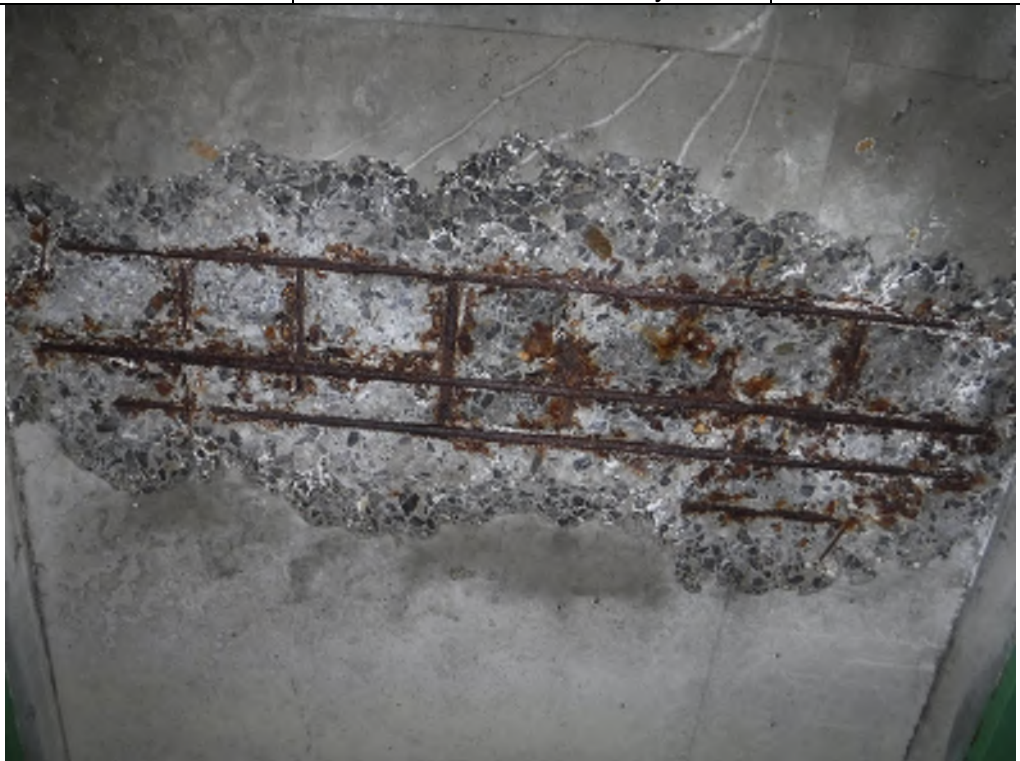
<b>PHOTO: 23</b>	<b>LOCATION:</b> <u>Span 10 Bay 7 between diaphragm D3-D4</u> <b>DESCRIPTION:</b> <u>Underside of deck exhibits a 18 SF spall with exposed rebar</u> <u>Looking East</u>

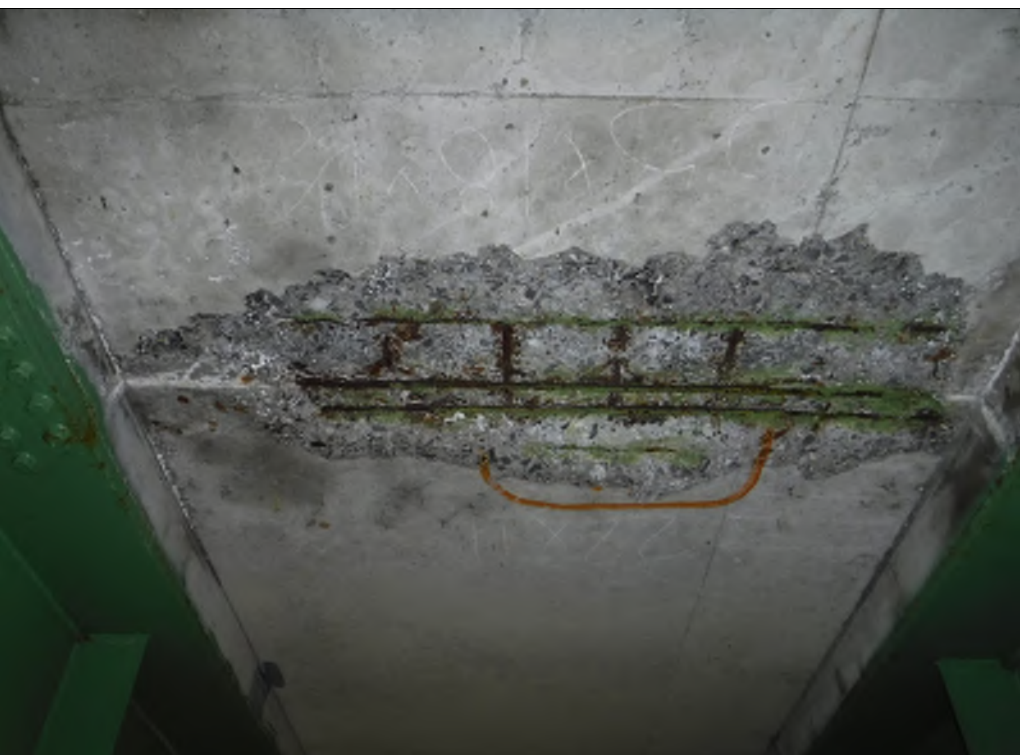
<b>PHOTO: 24</b>	<b>LOCATION:</b> <u>Span 10 Bay 6 between diaphragm D3-D4</u> <b>DESCRIPTION:</b> <u>Underside of deck exhibits a 12 SF spall with exposed rebar</u> <u>Looking East</u>

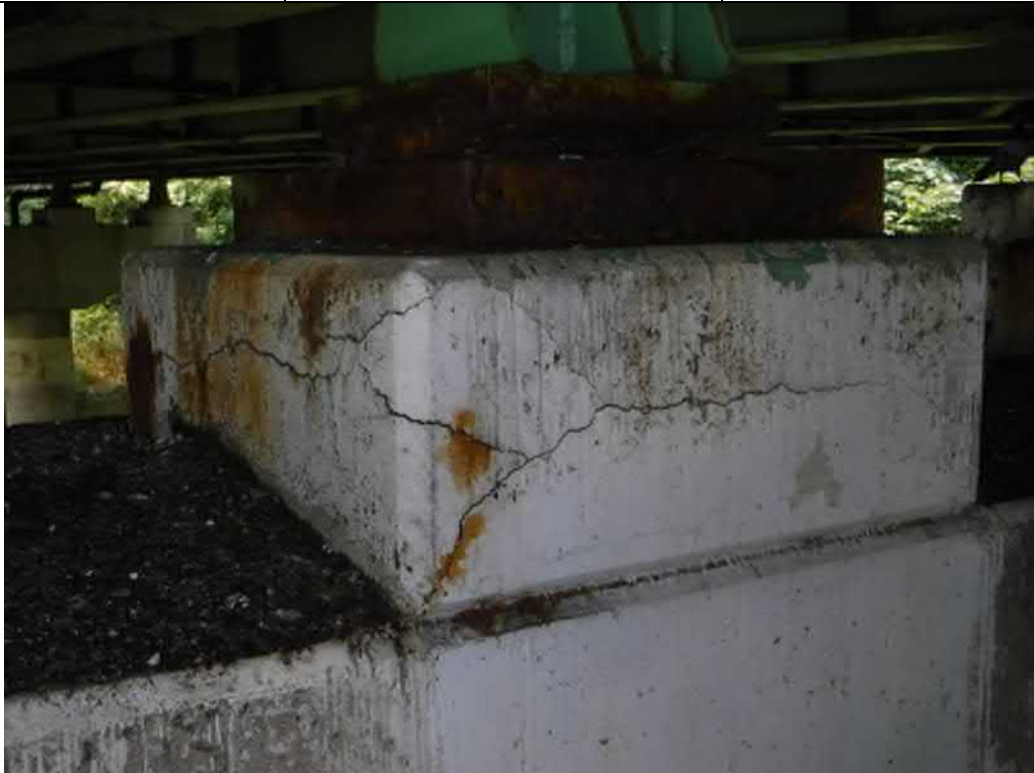
<b>PHOTO: 33</b>		
<b>LOCATION:</b> <u>Pier 3 Span 4 side Pedestal 7</u>		
<b>DESCRIPTION:</b> <u>Pedestal exhibits heavy cracking</u> <u>Looking Northwest</u>

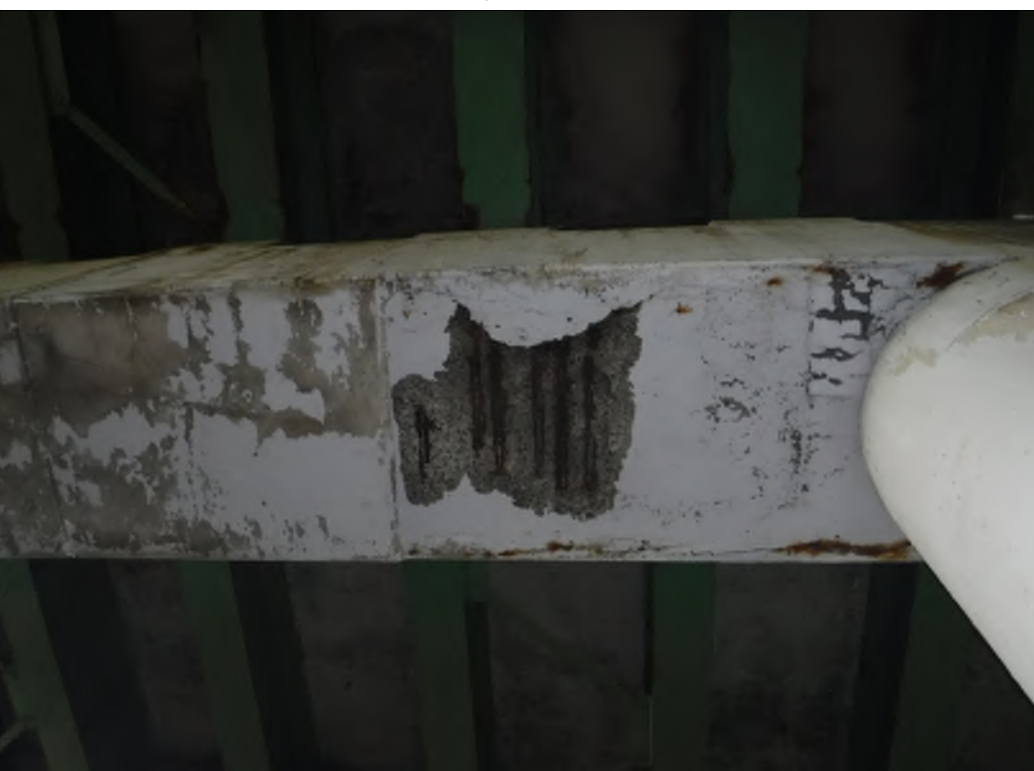
<b>PHOTO: 34</b>		
<b>LOCATION:</b> <u>Pier 3 North pier underside</u>		
<b>DESCRIPTION:</b> <u>Underside of pier exhibits 12 SF spall with exposed rebar</u> <u>Looking East</u>

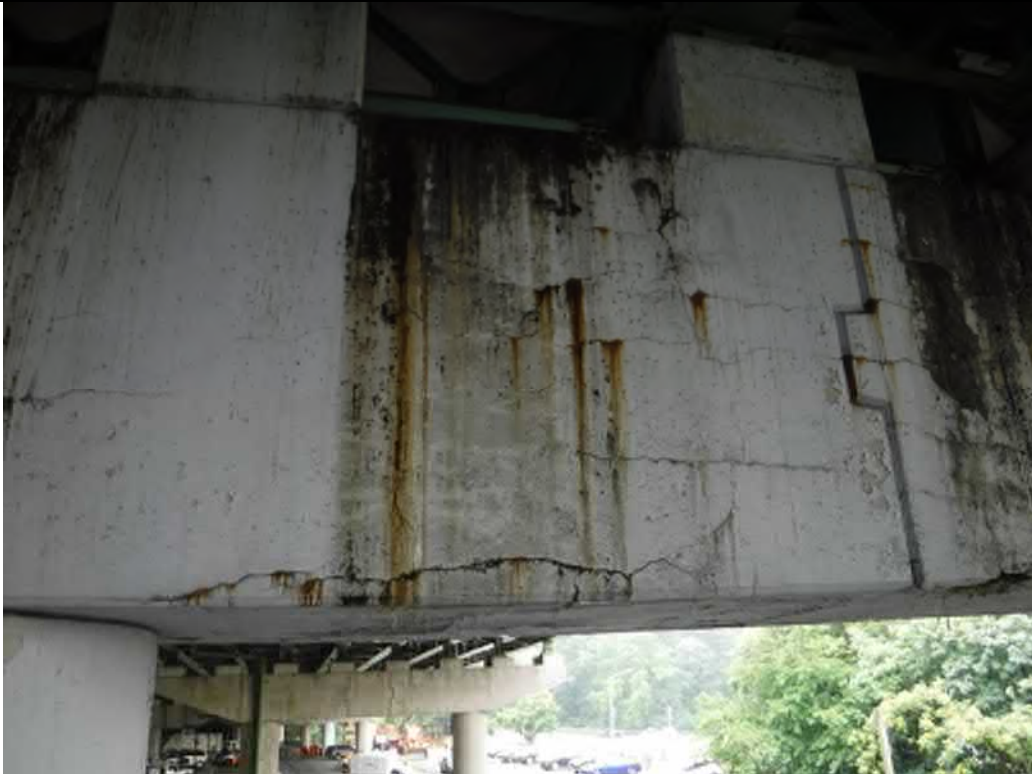
PHOTO: 35	<b>LOCATION:</b> Pier 6 West face South pier <b>DESCRIPTION:</b> Pier exhibits multiple cracks with water infiltration Looking East

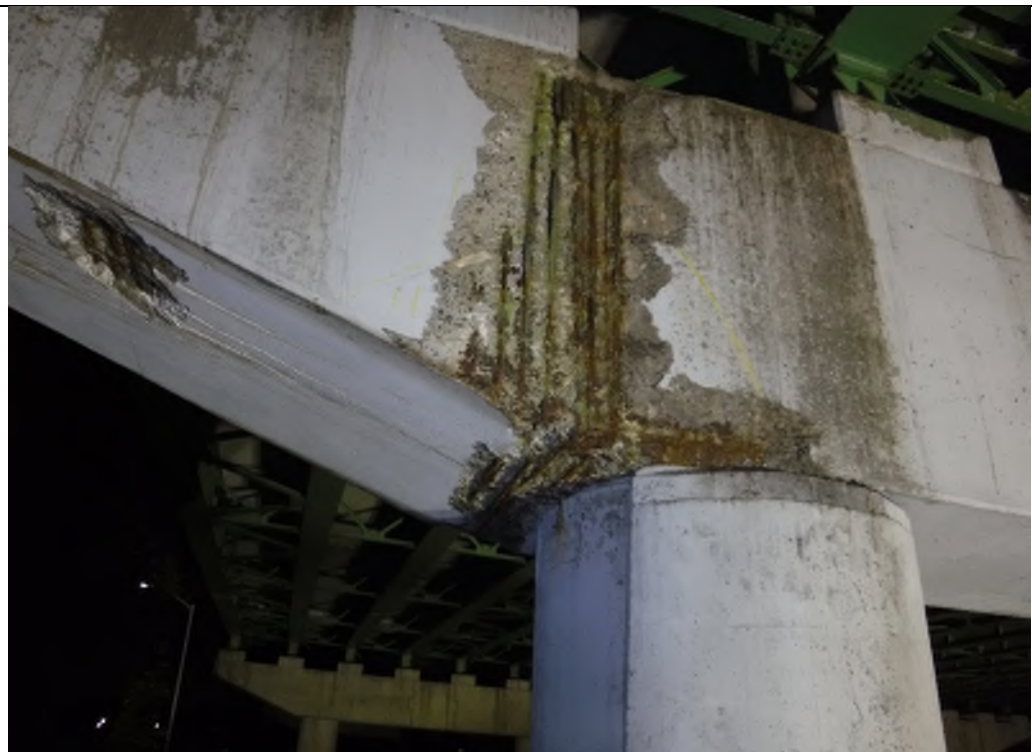
PHOTO: 36	<b>LOCATION:</b> Pier 6 South pier East face and underside by column C4 <b>DESCRIPTION:</b> Underside and face of pier exhibits 28 SF spall with exposed rebar, Looking West

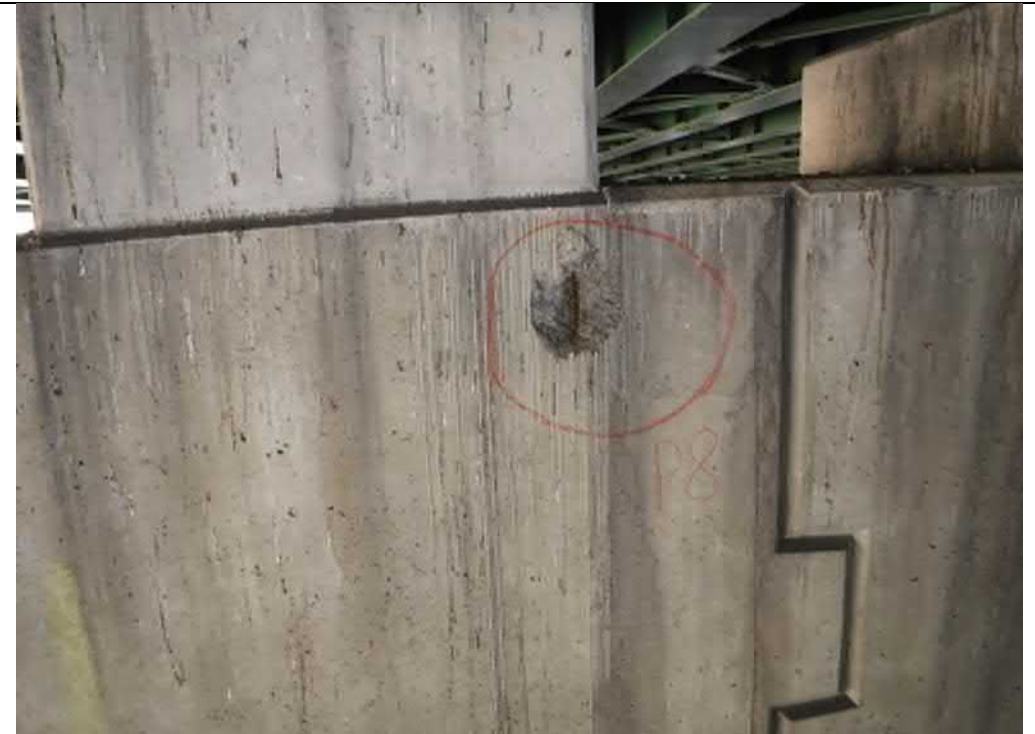
<b>PHOTO: 38</b>	<b>LOCATION:</b> Pier 8 East face by pedestal P6 <b>DESCRIPTION:</b> Pier exhibits 1 SF spall with exposed rebar Looking West

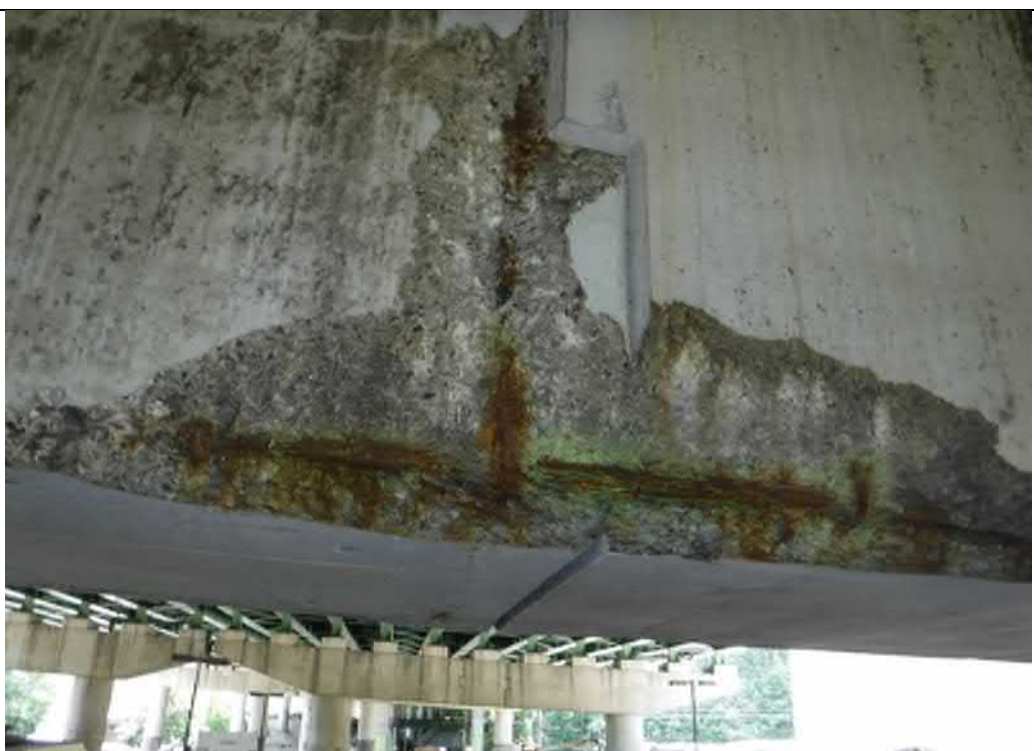
<b>PHOTO: 42</b>		
<b>LOCATION:</b> Pier 9 Span 10 side underside below pedestal P11		
<b>DESCRIPTION:</b> Pier exhibits 24 SF spall with exposed rebar Looking West

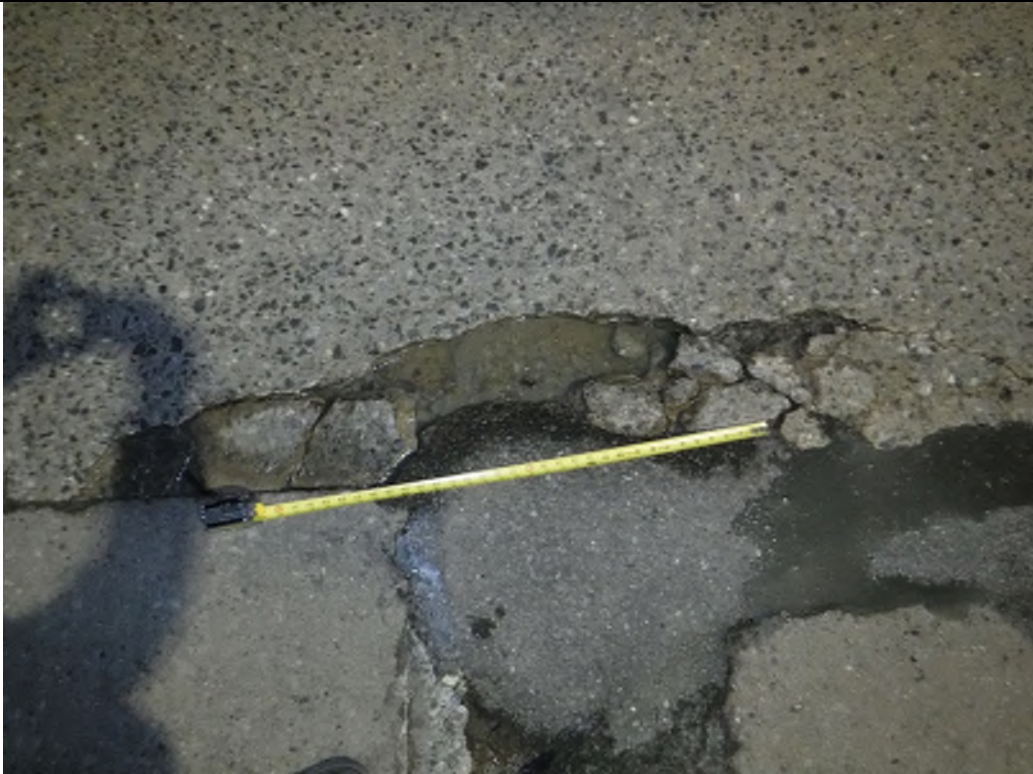
<b>PHOTO: 45</b>	<b>LOCATION:</b> <u>Westbound Span 1 center lane</u> <b>DESCRIPTION:</b> <u>Deck exhibits a 3 SF by 2" deep spall</u> <u>Looking South</u>

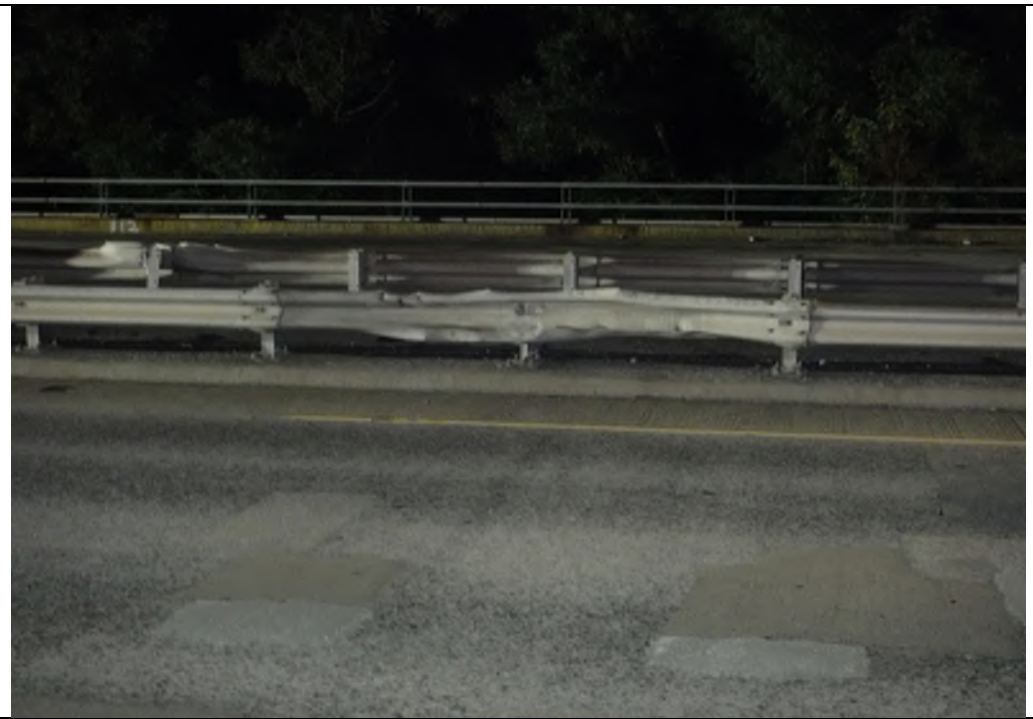
**Railings:** The railings are in good condition with no meaningful corrosion. There are signs of impact to the rails in several locations. Pier 1 South side exhibits lower rail being bent 4 inches upward and outward. Span 2 median guardrail exhibits damage from collision. No damage or corrosion related distress was noted in any of the railing posts. (see photos 46, 55).

<b>PHOTO: 46</b>	<b>LOCATION:</b> <u>Span 2 Eastbound Left guardrail</u> <b>DESCRIPTION:</b> <u>Guardrail has a 10' section damaged</u> <u>Looking North</u>

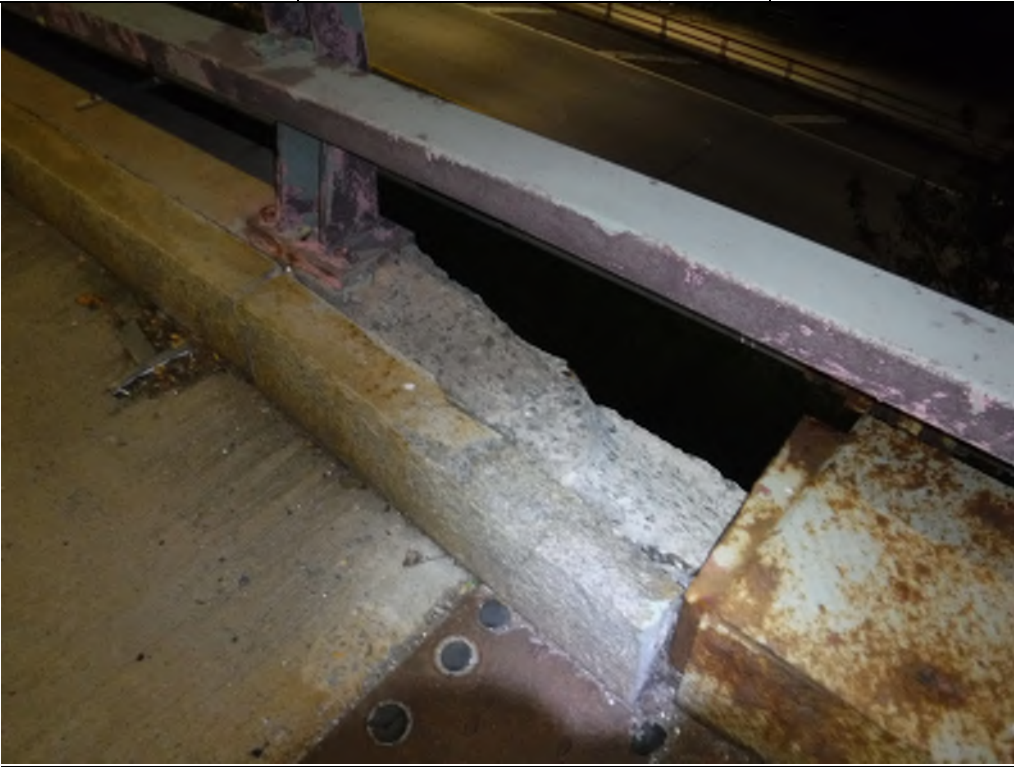
**Joints:** The sealant on both the West and East abutment is beginning to dry out and deteriorate and has accumulated debris. The finger expansion joints at pier 3, 6, 9 and 12 all have dirt and debris filled in the edges which inhibit the proper function of the joint. There is also evidence of water leakage on the piers and end diaphragms below the finger joints. (see photos 47, 48).

<b>PHOTO: 47</b>	<b>LOCATION:</b> Pier 3 Eastbound expansion joint South side <b>DESCRIPTION:</b> Parapet exhibits a 6 SF spall Looking South

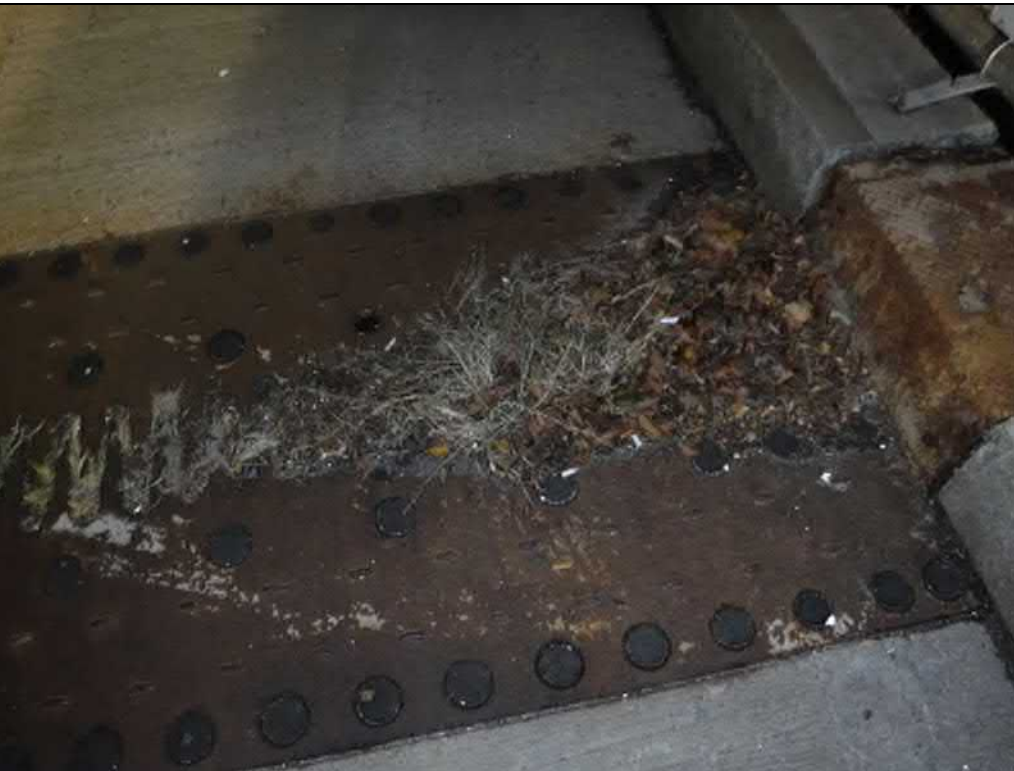
<b>PHOTO: 48</b>	<b>LOCATION:</b> Pier 9 expansion joint South end <b>DESCRIPTION:</b> Pier 9 finger joint filled with debris Looking East

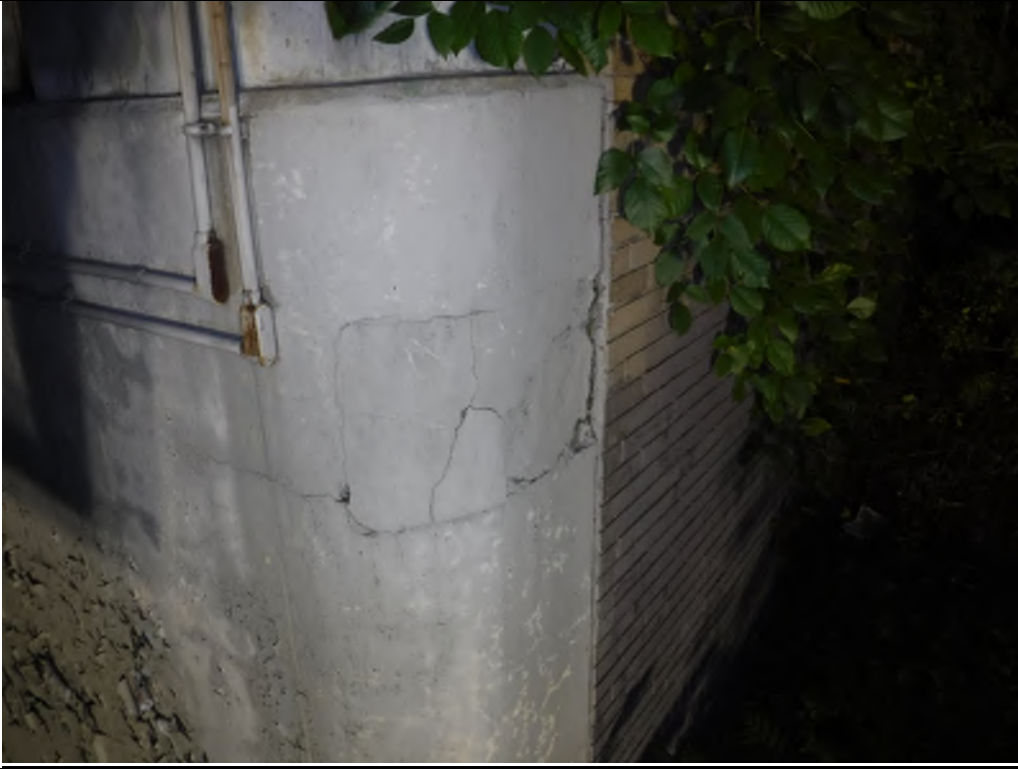
Ramp H abutment is in good condition and fully functional. The South face exhibits a 4 SF spall with cracking, the North face exhibits a 4 SF spall with exposed rebar. The North most electrical panel on the Ramp H abutment was partially open and unlocked. (see photos 53).

<b>PHOTO: 51</b>	<b>LOCATION:</b> <u>Ramp H abutment</u> <b>DESCRIPTION:</b> <u>South face of abutment exhibits a 4 SF spall with cracking</u> <u>Looking Northeast</u>

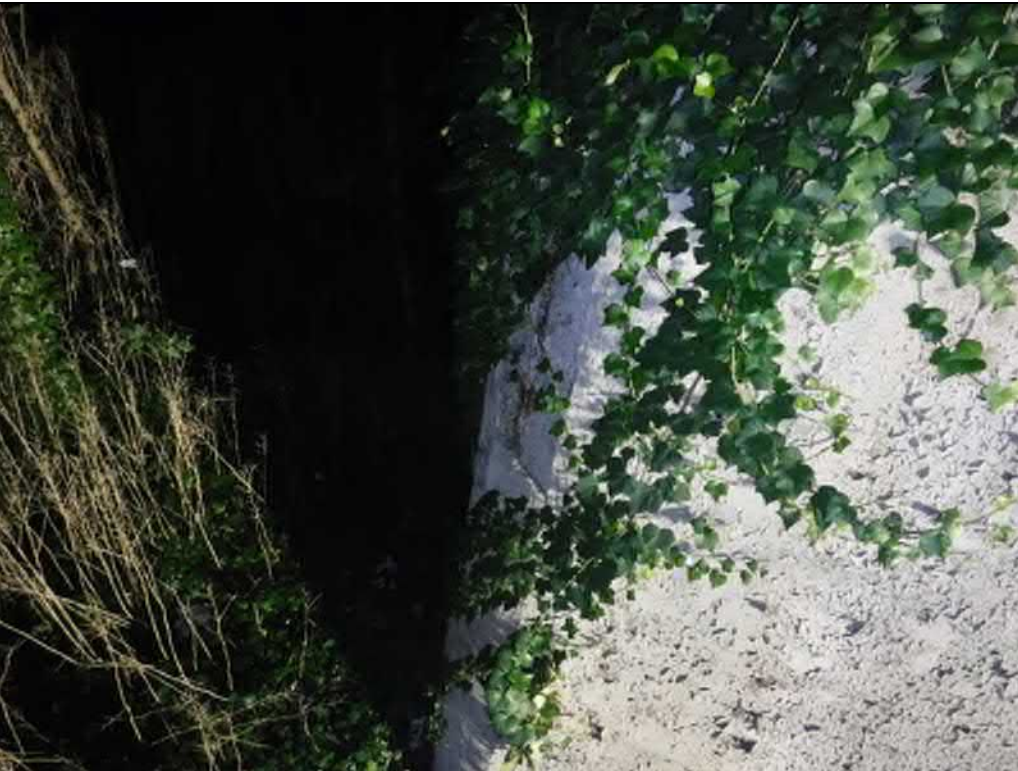
<b>PHOTO: 52</b>	<b>LOCATION:</b> <u>Ramp H abutment</u> <b>DESCRIPTION:</b> <u>North face of abutment exhibits a 4 SF spall with exposed</u> <u>rebar and heavy vegetation Looking East</u>

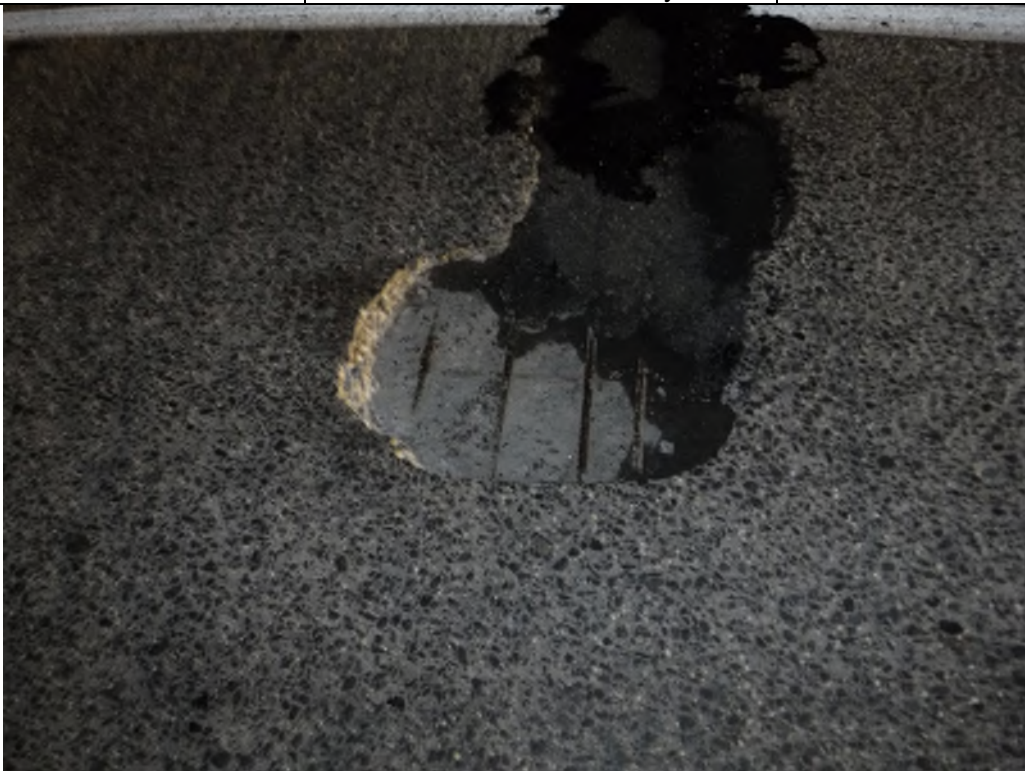
PHOTO: 57	<b>LOCATION:</b> <u>Ramp H Top of Deck near Pier 10</u> <b>DESCRIPTION:</b> <u>Deck exhibits a 2 SF spall with exposed rebar, asphalt patch worn away, Looking North</u>

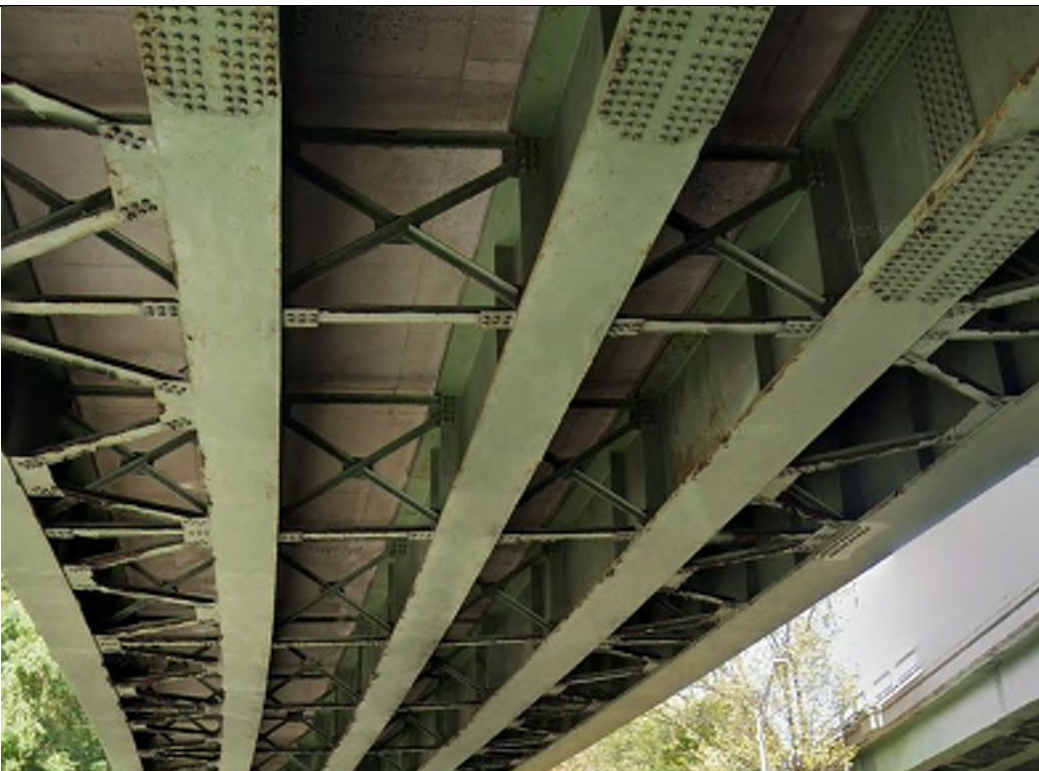
PHOTO: 58	<b>LOCATION:</b> <u>Ramp H Underside of Deck</u> <b>DESCRIPTION:</b> <u>Underside of deck displays areas paint chipping, splice shown approximately 40' East of Pier 10, Looking East</u>

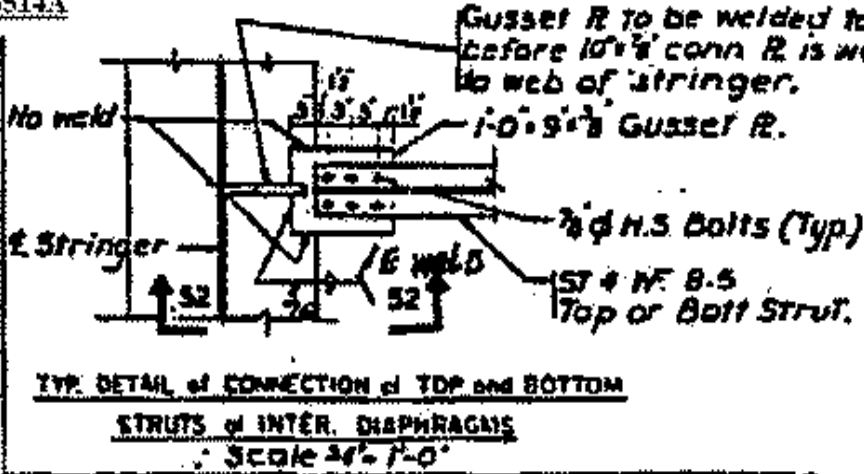
BIN: 106514A

NOTE: PERFORMED 100% HANDS-ON INSPECTION & TYPE E WELD @ BOTTOM END OF CONNECTION TO INTER DIAPHRAGMS

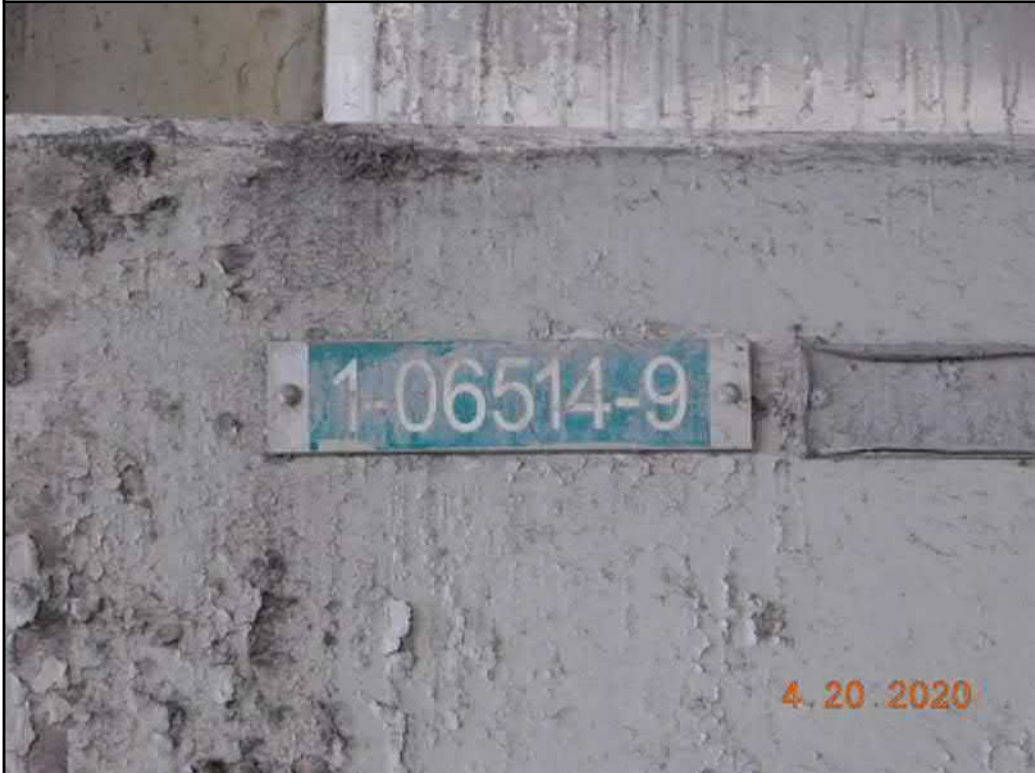
1. The BIN plate is located on the Begin Abutment Stem under Girder G9 and is in OK condition. (Photo 1)
2. 100% Hands-on inspection was performed at all horizontal gusset plate welds connecting lateral bracing to girder bottom flanges in all spans. (Photos 2-3) Ref. Special Emphasis Sketches.
3. A minimum of 20% area of the underside of the overhangs were sounded and no loose concrete was found.
4. Brick veneer at all Abutment Wingwalls was inspected and no loose bricks were found.
5. There are no changes to the Access or Electrical Forms. Updated Debris Form is attached.
6. Vertical Clearance sketches are attached.
7. Joint Maintenance Report is attached.
8. Standard Photos have been updated where appropriate.
9. Two NSCO Reports were issued during this inspection. Previously issued NSCO report for debris at the top of cap beams is not a safety issued, therefore it was not re-issued.

Location: Begin Abutment  
under Girder G9; Looking  
Back. BIN Plate in OK  
condition. Ref. General  
Notes.

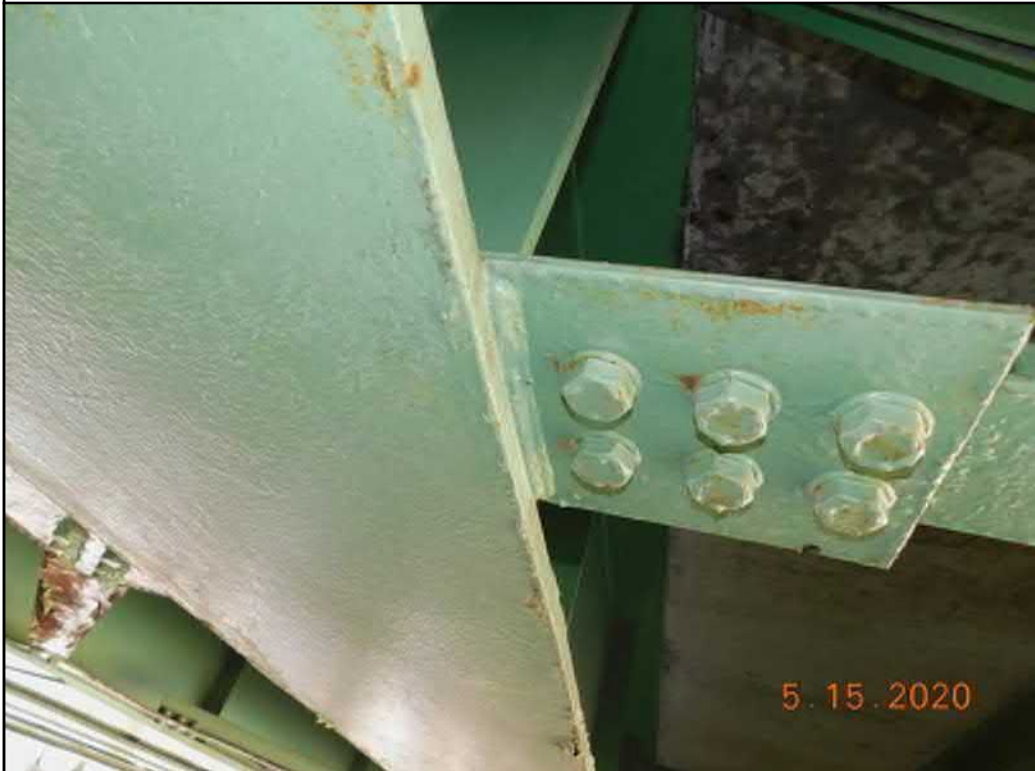
Photo Number: 2

Location: Span 9, Girder G7  
at Diaph. D4; Looking Back.  
Bottom flange weld. Ref.  
Special Emphasis.

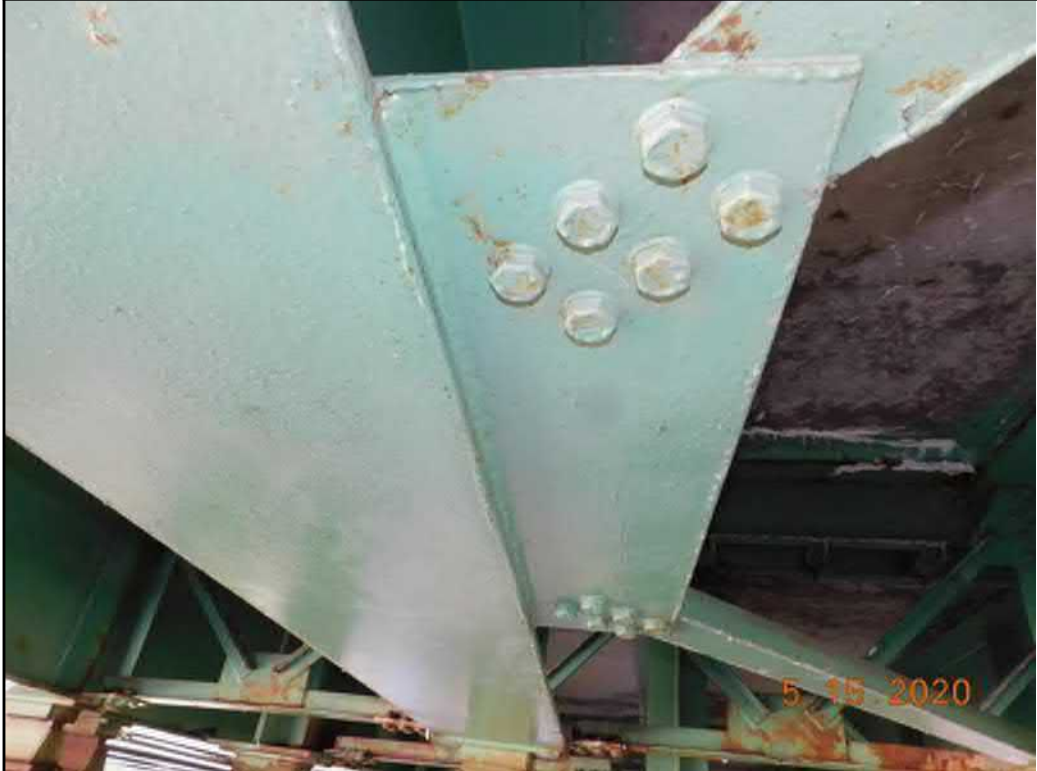
Photo Number: 3

Location: Span 9, Girder G4  
at Diaph. D5; Looking Back.  
Bottom flange weld. Ref.  
Special Emphasis.

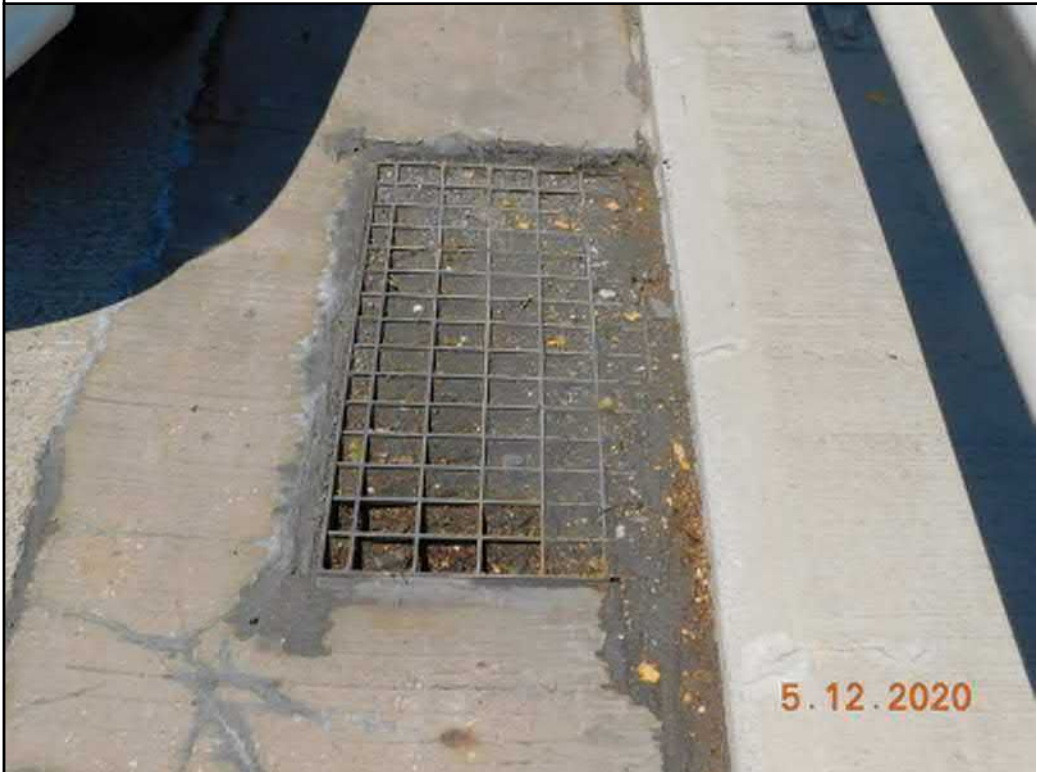
Photo Number: 4

Location: Span 5, E/B Left  
Lane; Looking Back.  
Clogged catch basin. Ref.  
NSCO.

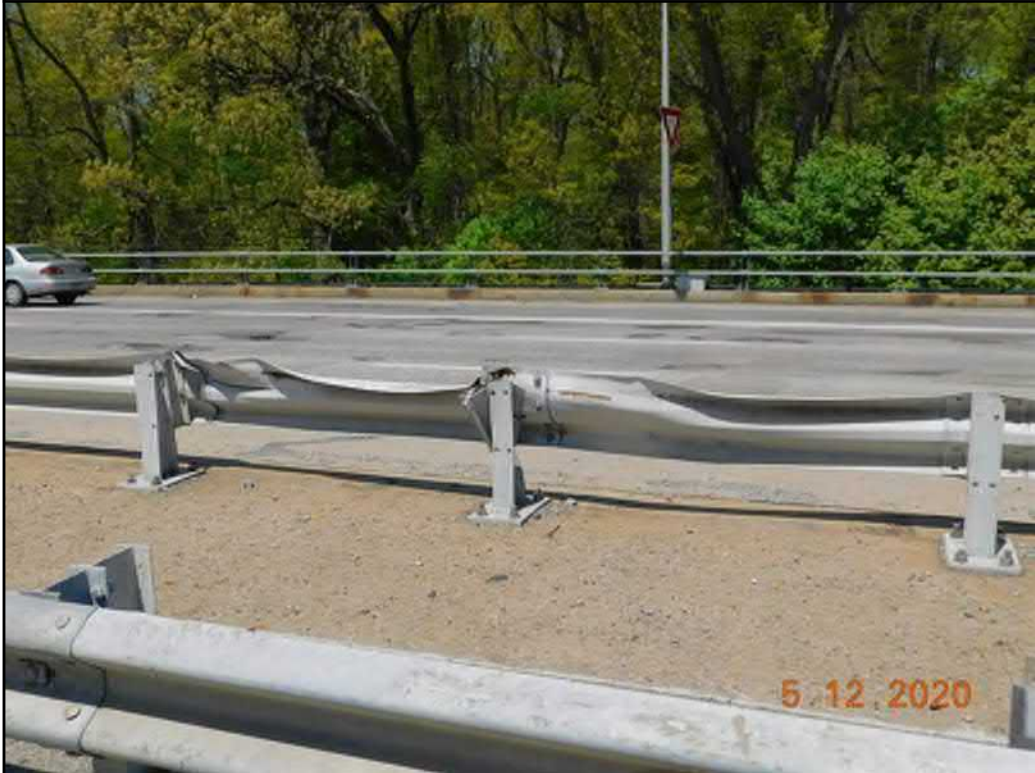
Photo Number: 5

447	317	112	18	0	0
	315	222	79	14	0	0
	336	240	84	12	0	0
	360	255	90	15	0	0
<b>Condition State 3 Note</b> <b>Referenced Photo(s):</b> 5, 6, 20 <b>Referenced Sketch(es):</b> None						
The median railing at the following locations has been impacted which has bent or broken the posts:						
-Span 2, E/B Median Railing: 10' (L) segment of impacted railing with one bent post. (Typical Photo 5) -Span 3, W/B Median Railing: 14' (L) segment of impacted railing with one bent post. (Photo 5) -Span 4, E/B Median Railing: 12' (L) segment of impacted railing with one bent post with a crack at its base. (Photo 6) -Span 15, E/B Median Railing: 15' (L) segment of impacted railing with one bent post with a crack at its base. (Typical Photo 6)

A NSCO report has been issued for these conditions.

**Attachment Description:**  
Location: Span 3, W/B  
Median Railing; Looking  
Left. Impacted railing with  
bent post. (Typical) Ref.  
NSCO.

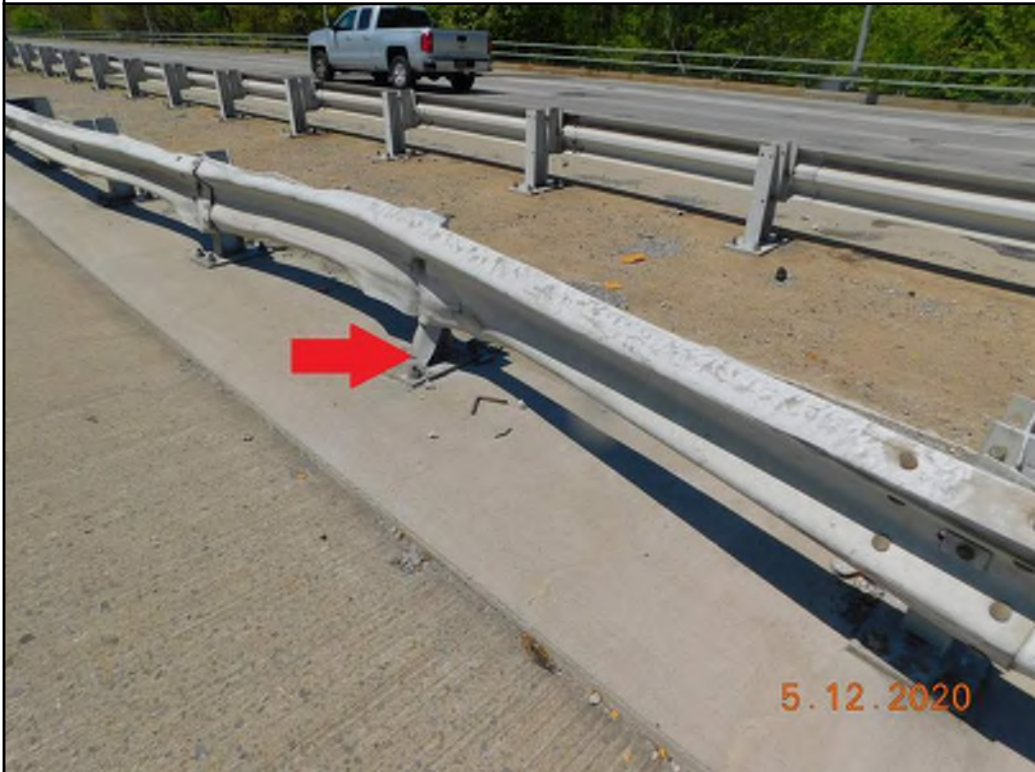
Photo Number: 6

**Attachment Description:**  
Location: Span 4, E/B  
Median Railing; Looking  
Back and Left. Impacted  
railing with bent/cracked  
post. (Typical) Ref. NSCO.

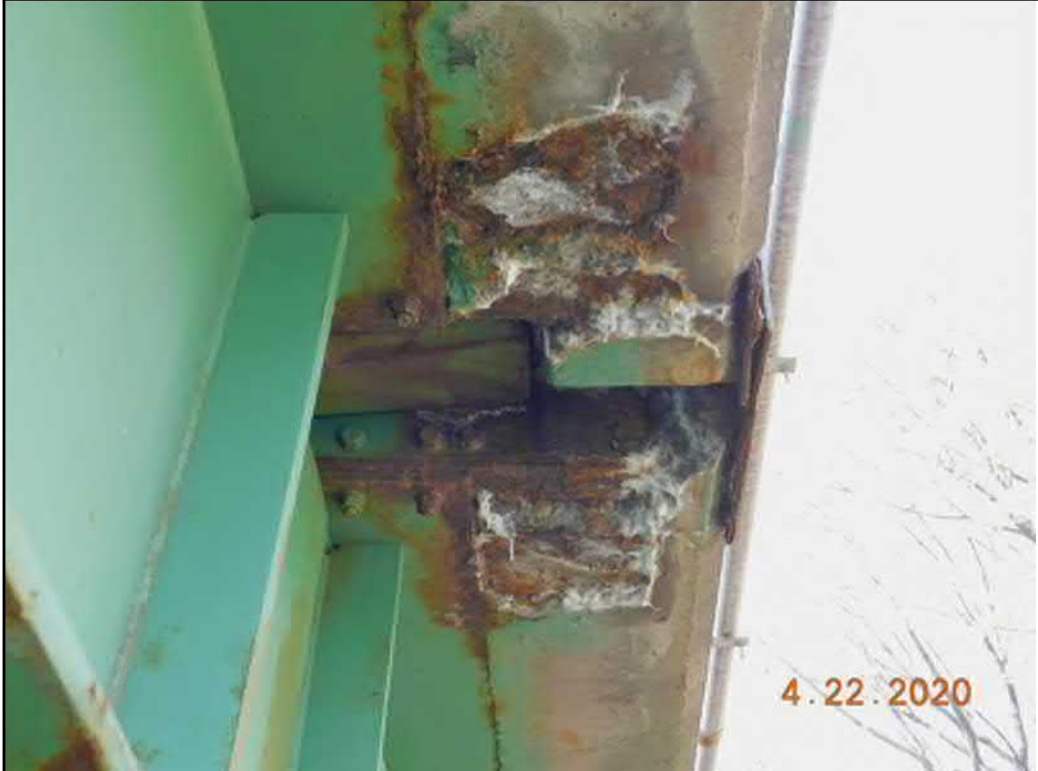
Photo Number: 9 Photo Filename: 20\_SW\_5616.JPG

- Spalls up to 3" deep with exposed epoxy painted or corroded rebar. (Photos 7-9,11,12, & 14)
- Transverse cracks up to 1/4" wide with/without efflorescence.(Photo 10 & 14)
- Fine mapcracking with/without efflorescence. (Photo 10,11, & 13)
- Areas of dampness on the underside of the deck due to seepage through the concrete deck. (Photo 10,11,13, & 14)

Location: Spans 6-7 Left Overhang at Pier 6; Looking Up and Back. Spalls with exposed rebar and efflorescence.
